Kingston Engineering has been providing an anti-corrosive/erosive coatings service for more than 30 years and in that time has been involved across a wide range of applications. Examples of the types of work where we have been able to help are shown below.

#### Surface Coatings and Treatments available

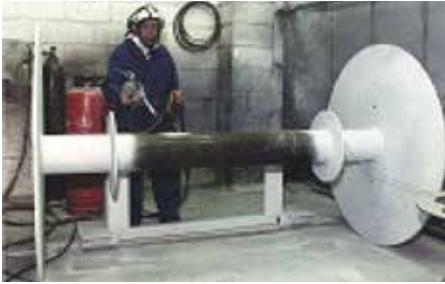
Metal sprayed coatings being applied to winch components for use in corrosive salt-water environment.

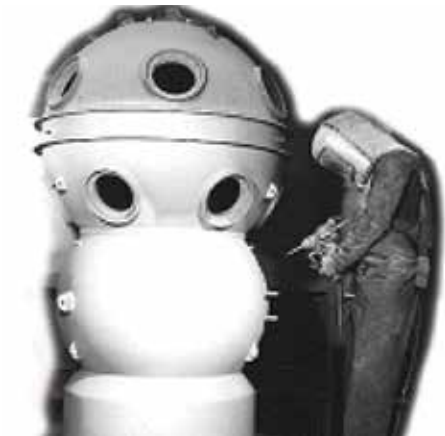
Zinc metal sprayed coatings being applied to the outer and inner surfaces of a Diving Bell.

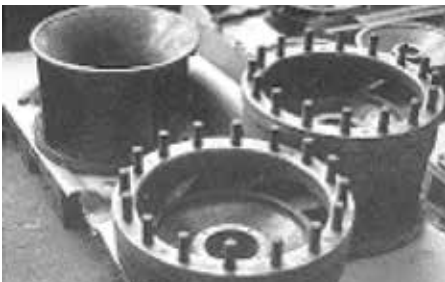
The badly worn internals of this Deepwell Multistage Pump were rebuilt and coated with Ceramic Metal giving extended life.

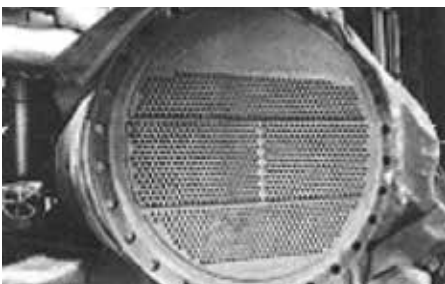
This Condenser End Plate was fully rebuilt with Ceramic Metal using specialised application techniques.

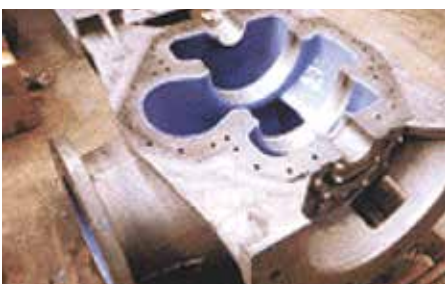
This badly corroded, Split Casing Circulating Pump was completely refurbished using Ceramic Metal. Overall coating provided erosion corrosion protection.
